CASE STUDY

Optimized Bearings and Dampers Provide Long-term Solution to Vibrations

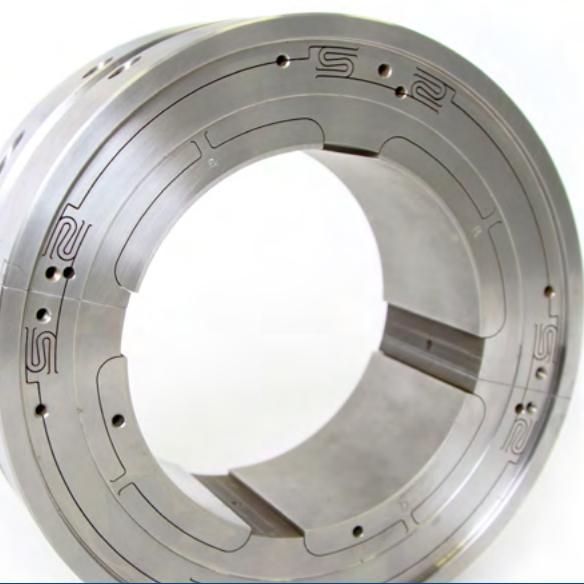
Figure 1: Flexure Pivot tilt pad journal bearing with ISFD technology

In 2013 the compressors were placed back in service with the optimized bearings and dampers (Figure 1). Since then the compressors have exhibited low vibration levels that do not grow over time. They have had no trips and have not required field balancing for continuous operation. Overall efficiency has increased by approximately 1% and site profits have improved.

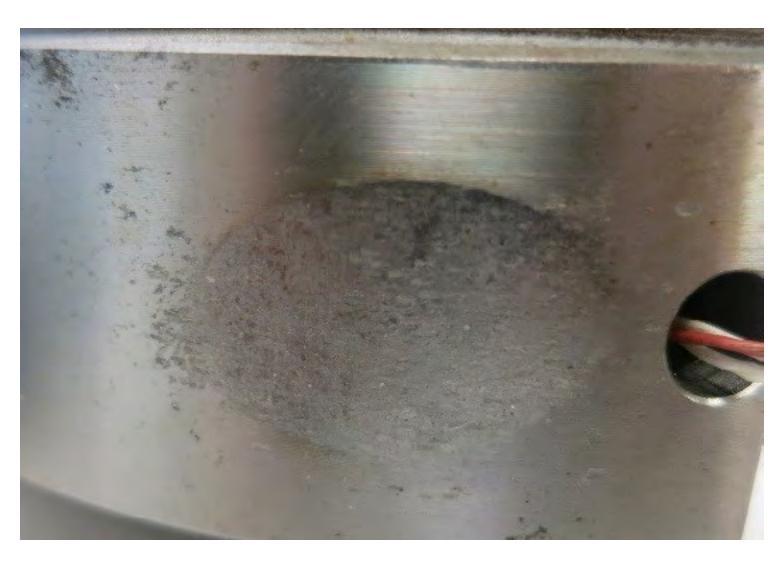
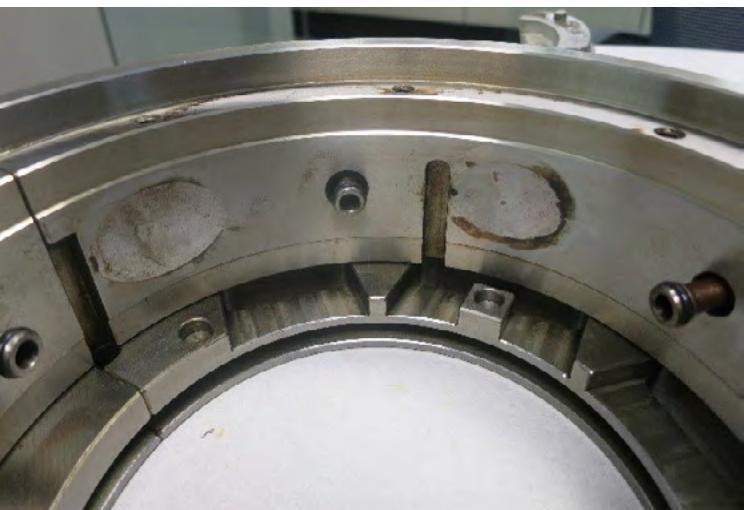
Inspection of the removed OEM bearings showed severe pivot wear on the tilt pads and bearing shell bore (Figure 2). This wear increased the bearing clearance by 63 microns or more in a five-month period, causing alarming vibrations. The inability of the O-rings to provide centering capability under static deflection, together with the increased vibrations, resulted in bearings bottoming out in the casing (Figure 3) and loss of squeeze film damper performance. These factors converged to increase vibrations over time in the LP casings of the compressors.

Figure 2: Pivot wear on the point-contact-pivot tilt pad (top) and bearing shell bore (bottom)

To address the pivot wear, Bearings Plus applied its proprietary Flexure Pivot TPJ bearing. The Flexure Pivot design has a pad and pivot that is integral to the bearing shell, eliminating metalto-metal contact between the pad and shell when the pad tilts (Figure 4). The bearing manufacturing method, electrical discharge machining (EDM), provides tight control of the clearance and preload for bearing optimization. By eliminating pivot wear, the Flexure Pivot TPJ bearing permanently maintains the original bearing clearance and original preload, changes in which can contribute to vibrations.

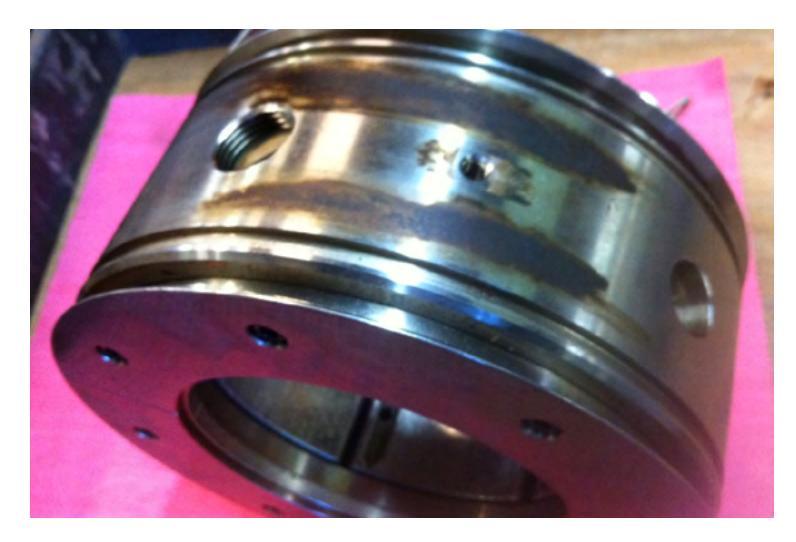
Figure 3: Damage on the OEM bearing outer diameter from bottoming out

The second part of the solution was the use of patented ISFD technology in place of the O-ring squeeze film damper. Like the Flexure Pivot tilt pad, the ISFD design is manufactured by EDM as part of the bearing itself, not a separate piece. The design offers many benefits over an O-ring damper, including accurate stiffness control, optimized damping, and the ability to center the rotor under static load. Moreover, ISFD technology eliminates changes in stiffness and damping over time. The integral squeeze film damper will not experience degradation or cause the bearing to bottom out, as O-rings can.

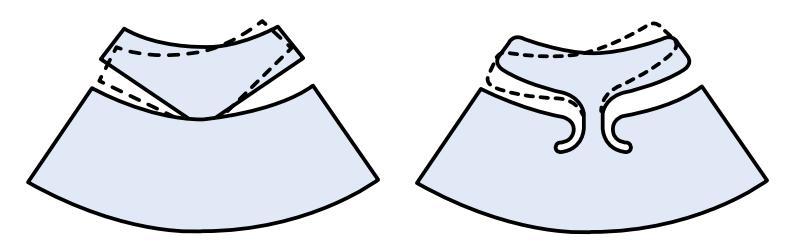
Figure 4: Conventional contact point tilt pad (left) and Flexure Pivot tilt pad (right)

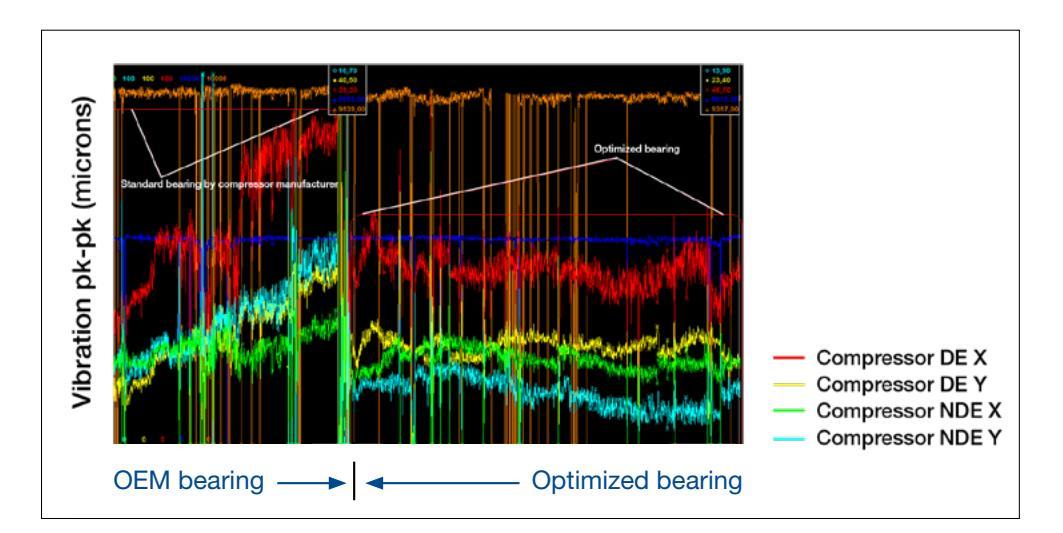
The three upgraded compressors all showed significant improvement with the optimized bearings and dampers. Compressor A vibrations dropped by more than half, Compressor B vibrations dropped from 90 μ m to less than 50 μ m (Figure 5), and Compressor C vibrations dropped to less than 30 μ m with the upgrade. The compressors have maintained the low vibration level over time (Figure 6). In addition, the optimized Flexure Pivot TPJ bearings with ISFD technology have eliminated the small subsynchronous vibrations experienced with the O-ring damper.

Figure 5: Compressor vibration trend with an OEM bearing over a six-month span followed by the upgraded bearing over a 10-month span.

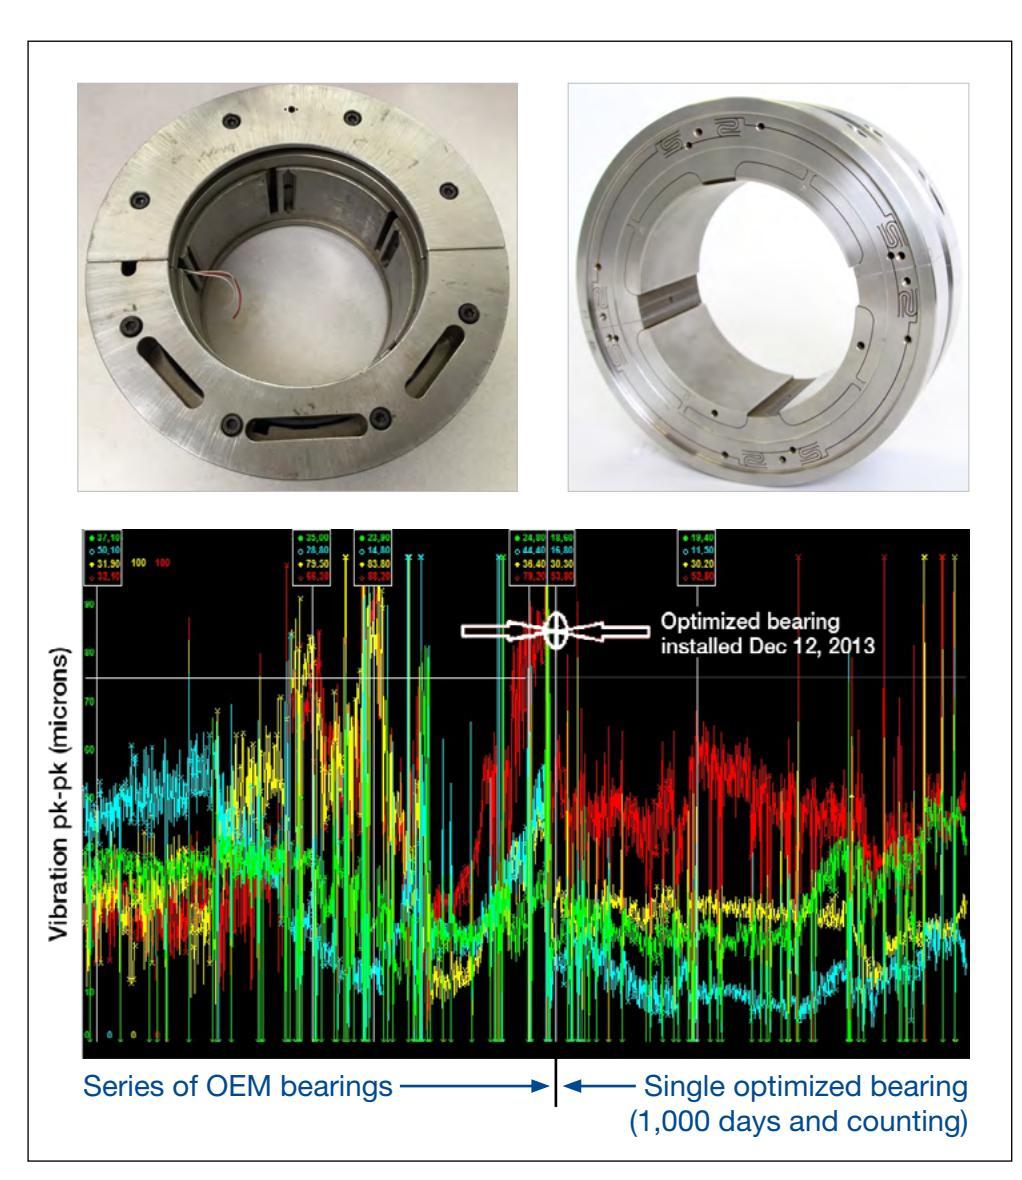
Figure 6: Compressor vibration trend with a series of OEM bearings (top left) over approximately 1,000 days followed by performance of an optimized bearing (top right) over a similar period. Vibration with the optimized bearing has remained steady with no problems and no bearing replacements.
